## Laboratory Report 4c-HRT-23-LSOTM-01.A.R2

**Uplift Resistance Testing**  
*of*  
**Lap Ridge and V Ridge Tiles**  
*in accordance with*  
**SSTD 11-97**

**Prepared for: Hecker Ridge Tile, LLC**

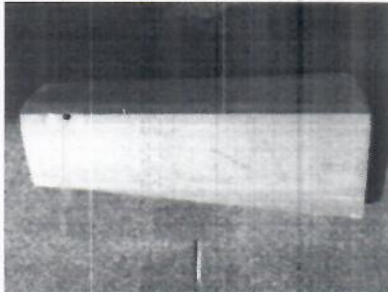
Fig. 1a. #12 x 4"-screw installed at tail (backmost hole) of Lap Ridge Tile

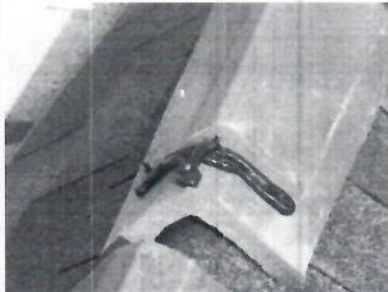
Fig. 1b. Two 6-in. long 0.25-in. wide beads of MasterSeal NP 1 at fastened tail of Lap Ridge Tile

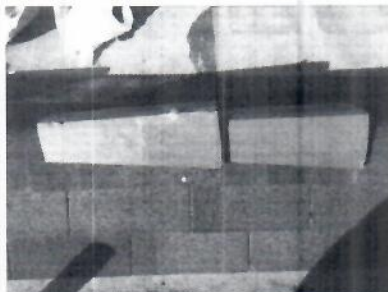
Fig. 1c. Lap Ridge Tile finished installation

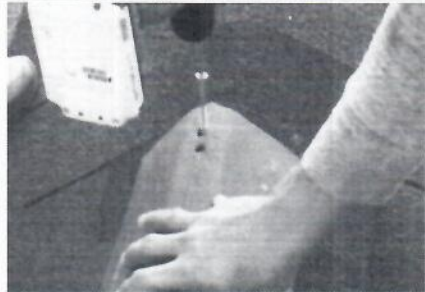
Fig. 2a. #12 x 4"-screw installed at tail (backmost hole) of Lap Ridge Tile

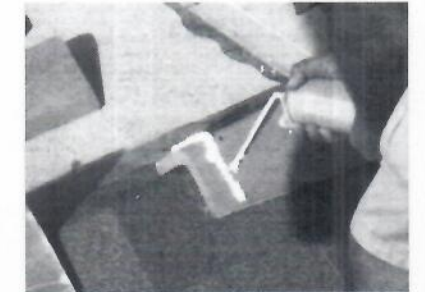
Fig. 2b. APOC 705 Polyset RTA-1 Roof Tile Adhesive applied to fastened tail of Lap Ridge Tile

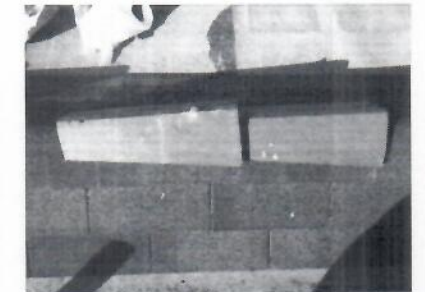
Fig. 2c. Lap Ridge Tile finished installation

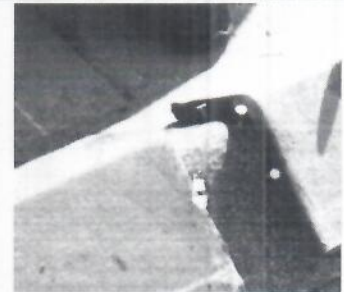
Fig. 3a. V Ridge Tiles with three (3) ring shank nails adjacent to the tail

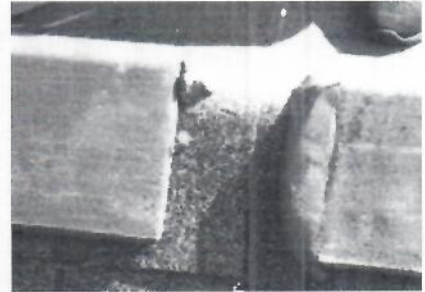
Fig. 3b. SAKRETE Portland Cement Type I-II applied to V Ridge Tiles, encasing the ring shank nails

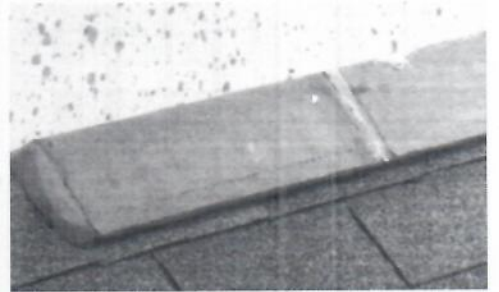
Fig. 3c. V Ridge Tile finished installation

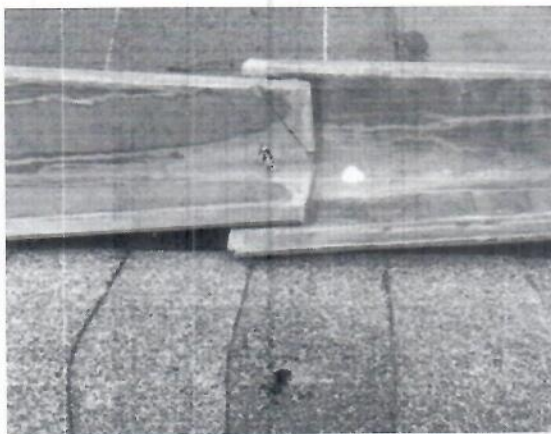
Fig. 4a. MOF, fastener withdrawal (typical)

TABLE 1A: TEST RESULTS, BUILD #1 LAP RIDGE TILE WITH MASTERSEAL NP 1				
<b>ATTACHMENT:</b>	#12 x 4-in. Stainless Steel wood screw at back-most hold of tile, 3-in. head lap, embedded minimum 2 inches into the 2x6 ridge board/structural member.			
<b>ADHESIVE RATES:</b>	MasterSeal NP 1: Two (2) 0.25-in. wide x 6-in. long beads of across tile-width at the 3-in. headlap and one (1) 0.25-in. x 3-in. long bead longitudinally across the fastener location			
<b>CURE TIME (DAYS):</b>	14			
Specimen #	Failing Load, lbf	Mode of Failure	Tile Deflection, in.	Tile Rotation
1	431.5	Fastener Withdrawal	< 0.25	None
2	420.0	Fastener Withdrawal	< 0.25	None
3	350.0	Fastener Withdrawal	< 0.25	None
4	433.0	Fastener Withdrawal	< 0.25	None
5	335.5	Fracture Tile	< 0.25	None
6	357.5	Fracture Tile	< 0.25	None
<b>Tile surface area, sq. ft</b>			<b>1.3</b>	
<b>Fastening system contribution to uplift, lbf</b>			<b>188.9</b>	
<b>Uplift resistance, psf</b>			<b>145.3</b>

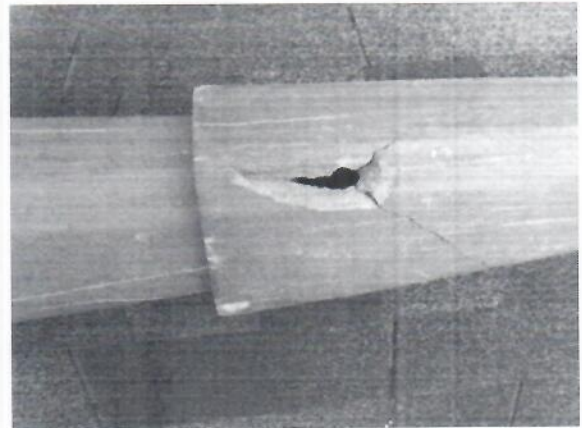
Fig. 4b. MOF, fracture tile (typical)

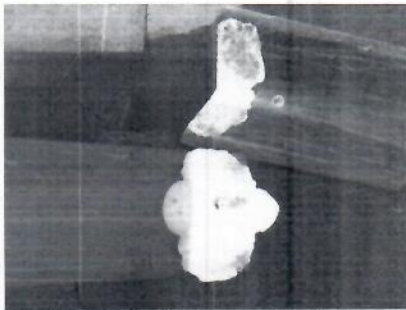
Fig. 5a. MOF, Cohesive foam (typical)

<b>ATTACHMENT:</b>	#12 x 4-in. Stainless Steel wood screw at back-most hold of tile, embedded minimum 2 inches into the 2x6 ridge board/structural member.			
<b>ADHESIVE RATES:</b>	APOC 705 Polyset RTA-1 Roof Tile Adhesive: One (1) ~1-in. wide x 6-in. long ribbon across tile-width at 3-in. headlap and one (1) ~1-in. wide x 2-in. long ribbon longitudinally over fastener location			
<b>CURE TIME (DAYS):</b>	14			
<b>Specimen #</b>	<b>Failing Load, lbf</b>	<b>Mode of Failure</b>	<b>Tile Deflection, in.</b>	<b>Tile Rotation</b>
1	461.0	Cohesive Foam	< 0.25	None
2	355.0	Fracture Tile	< 0.25	None
3	327.5	Loading Bolt Withdrawal	< 0.25	None
4	566.0	Fracture Tile	< 0.25	None
5	463.5	Cohesive Foam	< 0.25	None
6	379.0	Cohesive Foam	< 0.25	None
<b>Tile surface area, sq. ft</b>			<b>1.3</b>	
<b>Fastening system contribution to uplift, lbf</b>			<b>207.6</b>	
<b>Uplift resistance, psf</b>			<b>159.7</b>	
<b>Allowable overturning moment, ft-lbf</b>			<b>235.0</b>

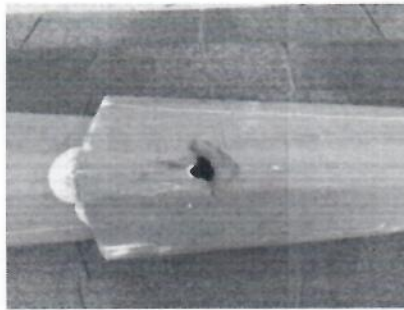
Fig. 5b. MOF, fracture tile (typical)

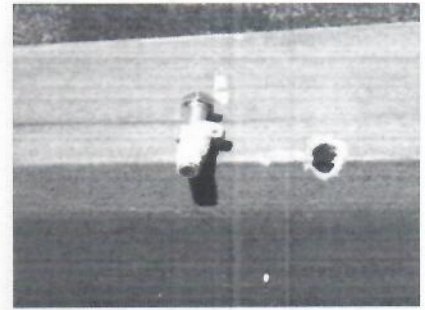
Fig. 5c. MOF, loading-bolt withdrawal (typical)

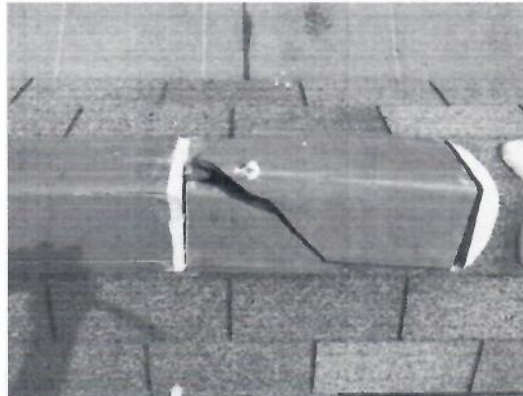
*Fig. 6. MOF, fracture tile (typical)*

<b>ATTACHMENT:</b>	Three (3) ring Stainless Steel shank nails adjacent to tile-ends at each butt-joint			
<b>ADHESIVE RATES:</b>	SAKRETE Portland Cement Type I-II mortar joints at each butt-joint, encasing the ring shank nails in mortar			
<b>CURE TIME (DAYS):</b>	28			
<b>Specimen #</b>	<b>Falling Load, lbf</b>	<b>Mode of Failure</b>	<b>Tile Deflection, in.</b>	<b>Tile Rotation</b>
1	439.5	Fracture Tile	< 0.25	None
2	287.0	Fracture Tile	< 0.25	None
3	244.5	Fracture Tile	< 0.25	None
4	404.5	Fracture Tile	< 0.25	None
5	299.5	Fracture Tile	< 0.25	None
6	311.0	Fracture Tile	< 0.25	None
<b>Tile surface area, sq. ft</b>			<b>1.5</b>	
<b>Fastening system contribution to uplift, lbf</b>			<b>160.9</b>	
<b>Uplift resistance, psf</b>			<b>107.2</b>	
<b>Allowable overturning moment, ft-lbf</b>			<b>223.8</b>	
<b>Lowest failure overturning moment, ft-lbf</b>			<b>133.1</b>
